**STATE OF CALIFORNIA
DEPARTMENT OF PUBLIC WORKS
DIVISION OF HIGHWAYS**

HORIZONTAL DRAINS ON CALIFORNIA HIGHWAYS

T. W. Smith
Senior Materials and Research Engineer
Materials and Research Department
California Division of Highways
Sacramento, California

Presented at the
Annual Convention A.S.C.E.
New York City, New York

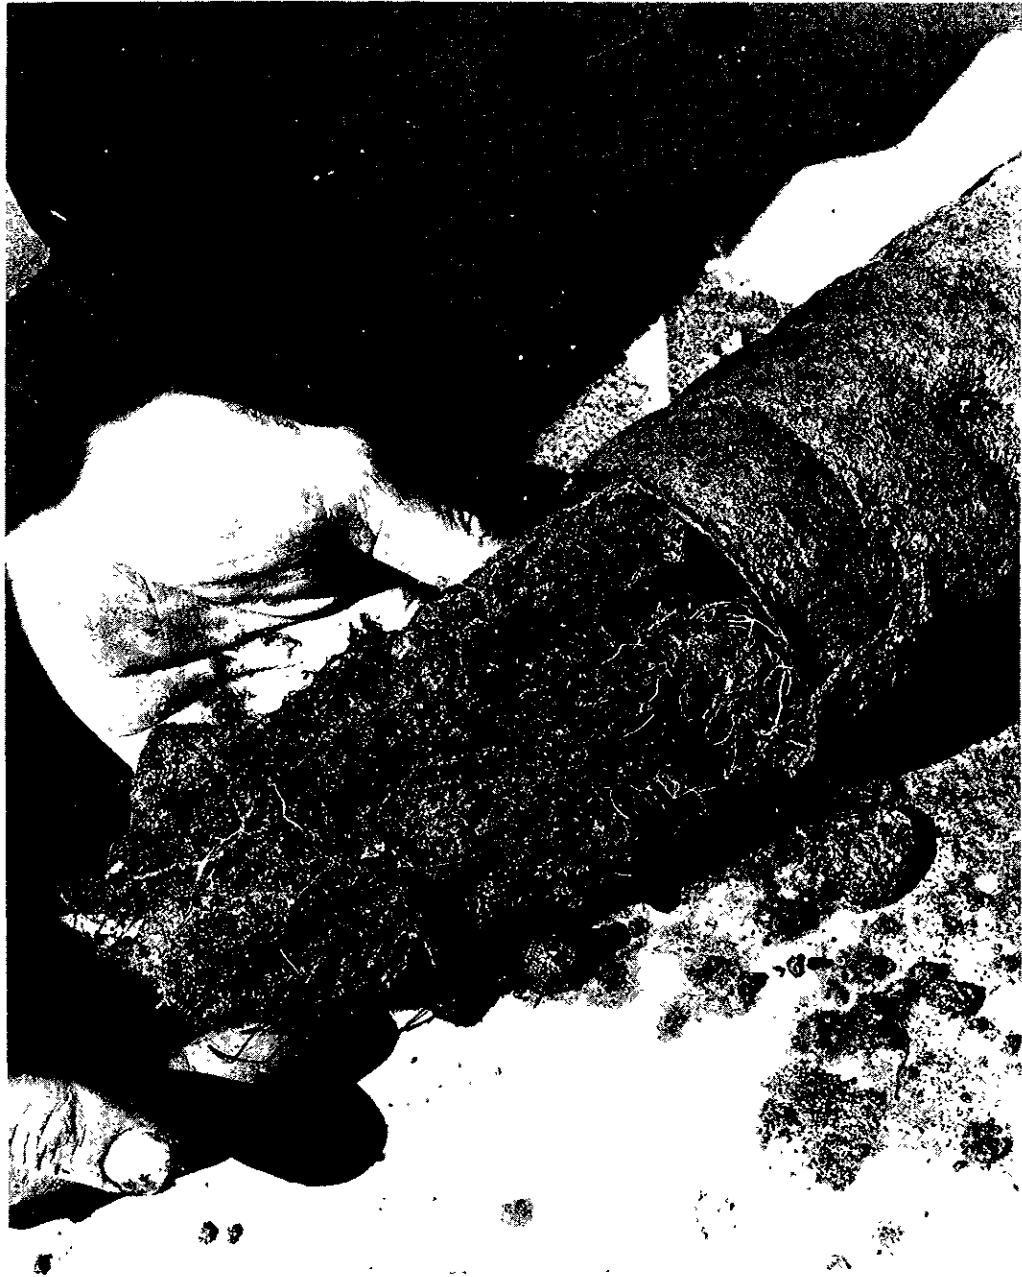
Considerable maintenance has been eliminated by the use of approximately 20 lineal feet of non-perforated galvanized pipe for the last length of casing placed in the boring. This, in most cases, minimizes trouble from root growth in the casing and retards corrosion at the outlets. (Fig. 11). Aside from regular inspection and repair of visible damage and obstructions the major maintenance consists of cleaning at intervals of three to ten years to remove root growth, corrosion, and soil from drains.

Fig. 11. Extreme case of root growth in horizontal drain.

While limited cleaning may be done with hand tools the only satisfactory method has been with the use of power equipment. This is usually accomplished with the original installation equipment modified for this purpose or with a relatively light hand-held air motor similar in operation to the original horizontal drain machine. Diamond drill E-rod with an auger type bit small enough to rotate freely in the casing is used for the drilling tools. Some of the water

jets of the cleaning bits are so directed that the casing is thoroughly washed and flushed as the bit progresses through the casing. Water delivered to the air motor at 150 psi to 200 psi has proven adequate. Standard practice has been to clean the drains to a 50 ft. minimum depth or 10 ft. beyond the point where the flushing water becomes clear when greater cleaning depths are necessary.
